# NATIONAL ADVISORY COMMITTEE FOR AERONAUTICS

No. 1432

### CHANGES FOUND ON RUN-IN AND SCUFFED SURFACES OF STEEL, CHROME PLATE, AND CAST IRON

By J. N. Good and Douglas Godfrey

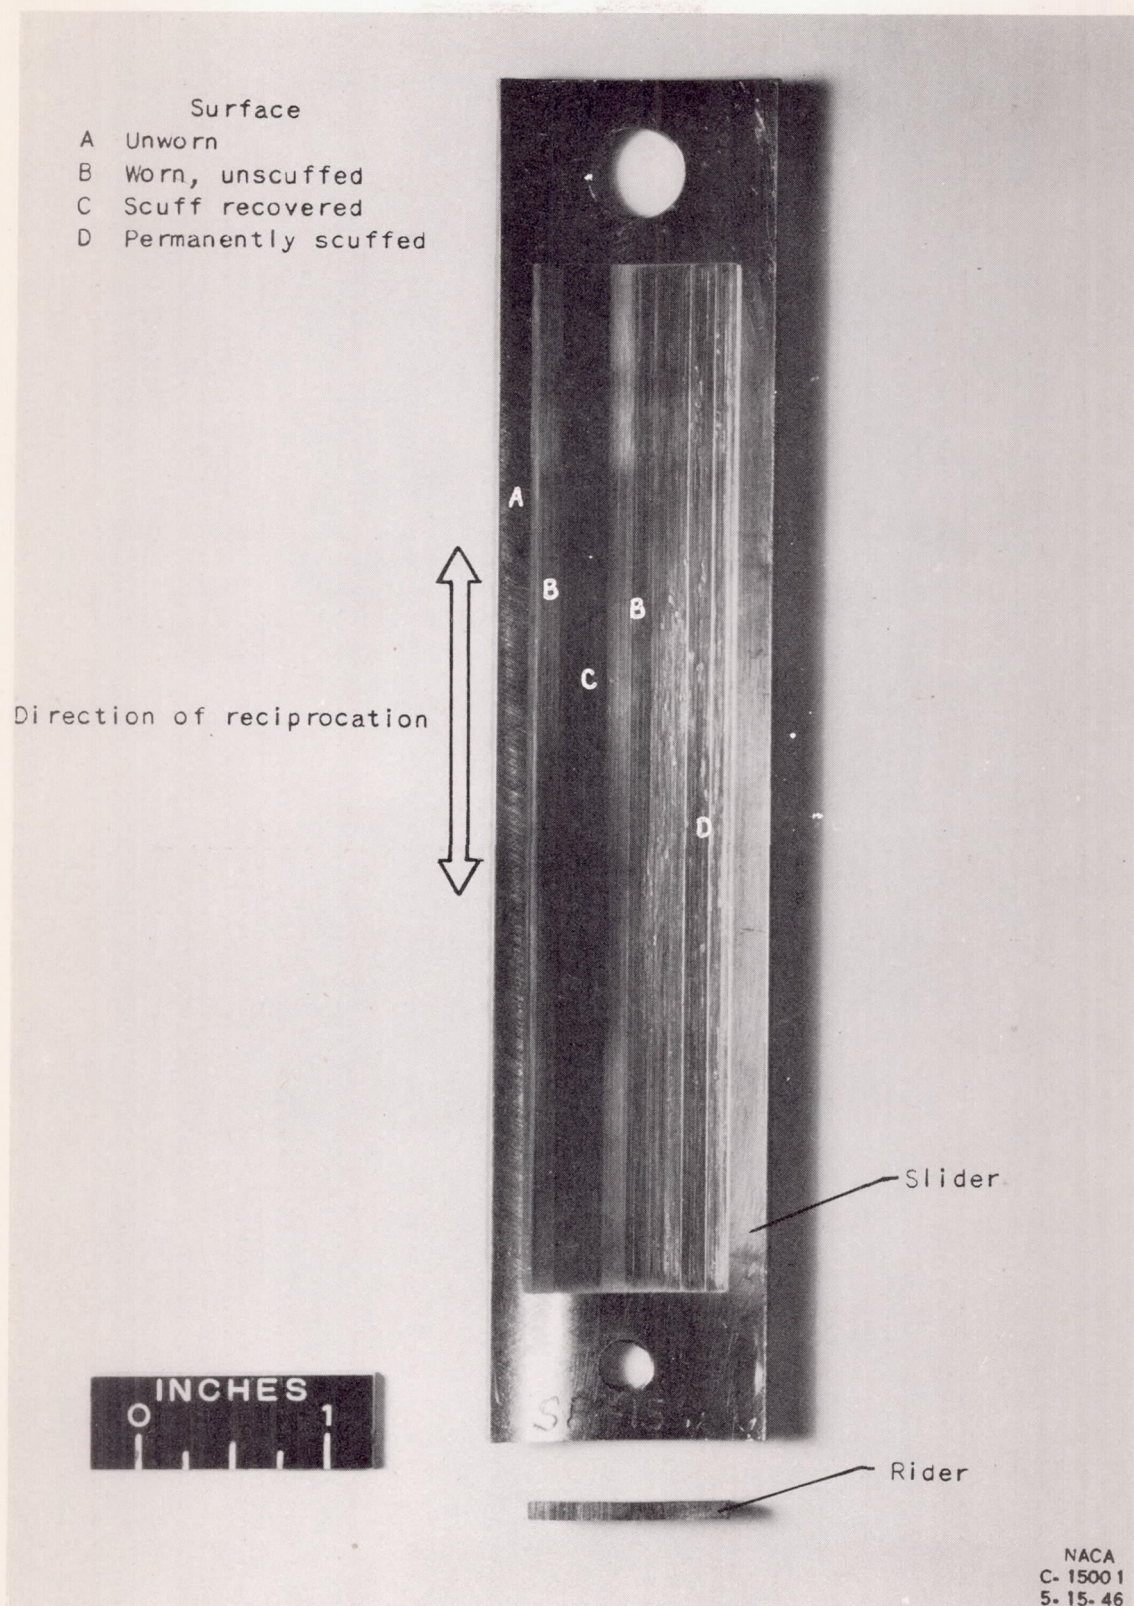
With the slider-rider combination of SAE 4140 steel and cast iron, several conditions occurred successively in strips, or zones, on the steel slider (fig. 2). The production of more than one surface condition on one specimen was due to slightly imperfect mating of rider and slider. The manner in which surface changes progressed represents various steps in increased loading until failure. Identification of the surface conditions is as follows: A represents the original unworn (unrun) surface; B represents a worn but unscuffed surface; and C represents a surface that appeared to have entered an initial condition of scuff rather early in the experiment but to have almost immediately recovered. Close observation during the run revealed a momentary darkening in color and then a change to dark gray. The permanently scuffed surface that developed in several stages, which succeeded each other within a few seconds, is represented by D. The first stage of formation was indicated by the momentary appearance of a dark-brown or reddish-brown surface color, which changed to black. The change in color was accompanied by the appearance in the recovered oil of a sediment whose major constituent was analyzed as alpha ferric oxide  $\alpha\text{-Fe}_2\text{O}_3$  by X-ray diffraction methods.

The appearance of bright spots and heavy scuff marks on the surface accompanied by a sharp increase in temperature indicated permanent scuff. It appears that because of the initial imperfect mating a shifting of load took place, which led to variations and irregularities in local load concentrations. Surface B may be considered to have carried a large portion of the load during the mating procedure and therefore to have been able to support the load as it was increased. As the load was increased, surface C suddenly appeared. This appearance occurred as a result, possibly, of slight warping as the temperature rose and because surface C may have been insufficiently mated at the time the load increased. As the load was further increased, strip D appeared, possibly because of a combination of higher load and further warping until the surface scuffed rapidly with so much progressive damage that the scuff became extensive and permanent.

Figure 2. - Run-in and scuffed SAE 4140 steel slider and cast-iron rider showing types of surface on slider.

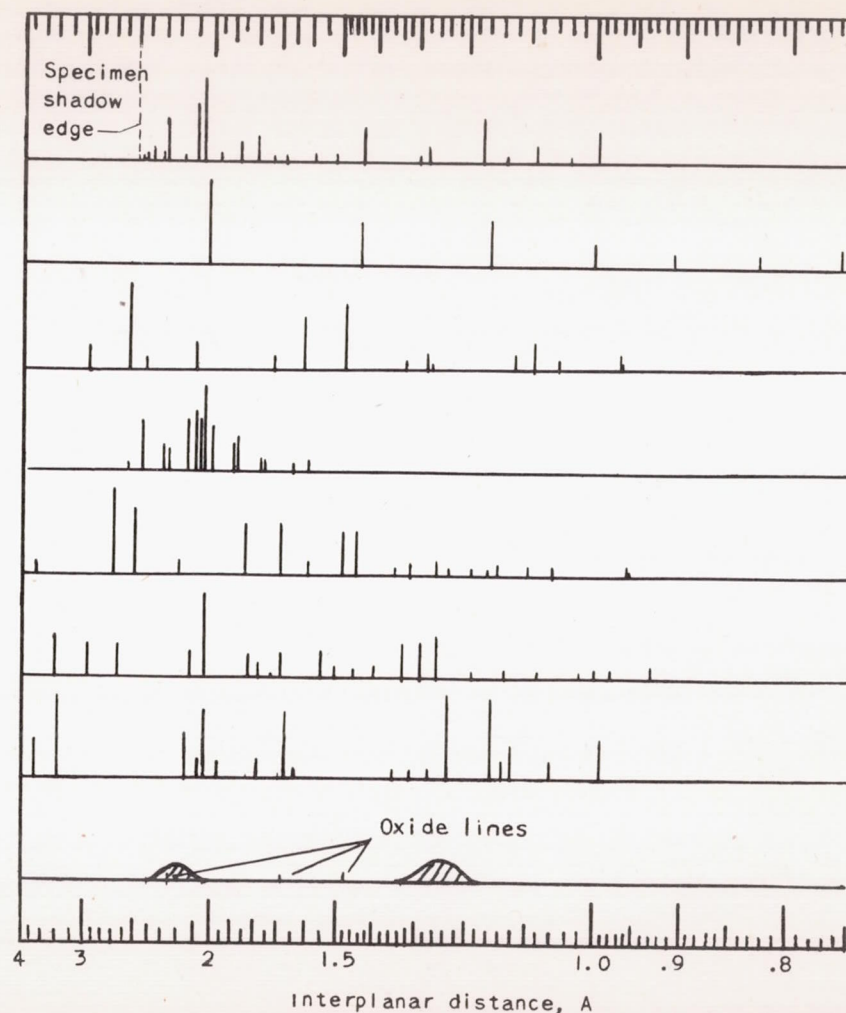
Identification of alpha iron,  $\alpha$ -Fe, ferrosoferric (ferrosic) oxide,  $\text{Fe}_3\text{O}_4$ , and iron carbide,  $\text{Fe}_3\text{C}$ , in these surfaces was made by X-ray diffraction. (See fig. 3.) (Whenever  $\text{Fe}_3\text{O}_4$  is mentioned herein, the possibility that it could also be  $\gamma$ - $\text{Fe}_2\text{O}_3$  should be considered, because the two are indistinguishable by usual diffraction methods.) On all four surfaces (A, B, C, and D),  $\text{Fe}_3\text{O}_4$  was considered present and gave an apparent maximum diffraction intensity for scuff-recovered and a decreased intensity for scuffed conditions as judged from the number of lines and from the changes in visual intensity. The identification of  $\text{Fe}_2\text{O}_3$  on surfaces B, C, and D was questionable. Iron carbide was identified on the scuffed surface D and questionably identified on scuff-recovered surface C. The intensities were greater for the scuffed than the scuff-recovered surface. No  $\text{Fe}_3\text{C}$  was identified on the unscuffed surfaces.

Figure 3. - Typical electron and X-ray diffraction patterns from surfaces of specimens of SAE 4140 steel slider and aircraft-engine cylinder barrel and standard X-ray diffraction patterns of materials identified.

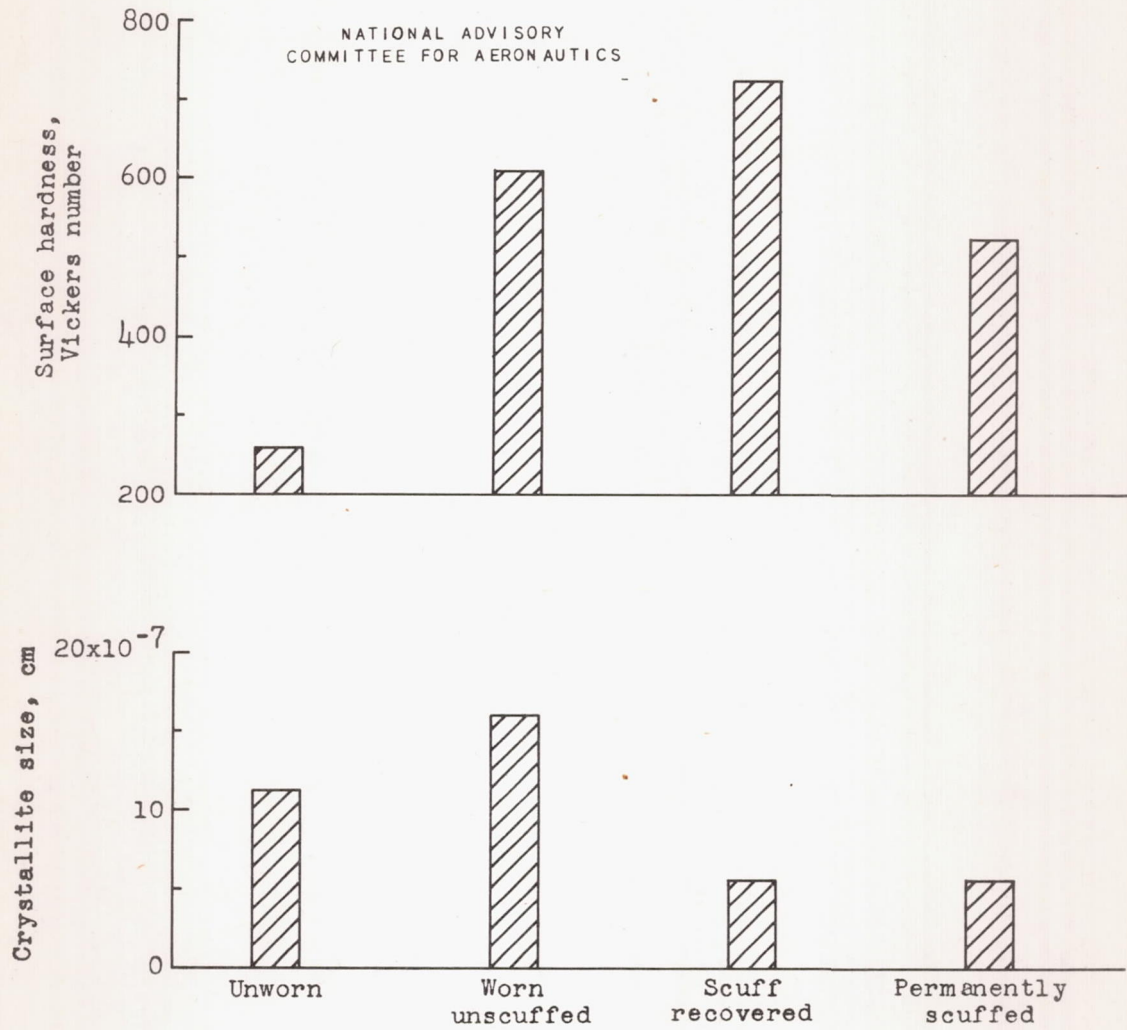
The results of the determination of crystalite sizes are presented in figure 4 and the X-ray patterns showing the differences are shown in figure 5. The hardness of the four surface conditions is also shown in figure 4; maximum hardness existed on the scuff-recovered surface.

The crystallite size and the hardness of the wearing surfaces are possibly as important as the chemical reactions. The relations between crystallite size and hardness for steel, chrome, and cast iron vary as shown in figures 4 and 9 and are somewhat complex. The average hardness of the SAE 4140 steel for the scuffed and scuff-recovered surfaces was greater than the average hardness of the unscuffed surfaces, and by similar comparison the crystallite size was smaller. In conjunction with these facts, the formation of the iron oxides and carbide on the scuffed surfaces is noted. If the change in hardness is to be attributed

to one of the other changes, it seems to follow chemical reaction best. The occurrence of  $\text{Fe}_3\text{O}_4$  in its greatest quantity coincided with the greatest hardness on the scuff-recovered surface, and a drop in hardness on the scuffed surface coincided with an indicated reduction in the amount of  $\text{Fe}_3\text{O}_4$ . This concept of a general relation of hardness to chemical reaction may or may not be weakened, however, by the occurrence of  $\text{Fe}_3\text{C}$  with the lower hardness of the permanently scuffed surface.

Figure 4. - Relation between surface changes and surface condition of SAE 4140 steel slider specimens.

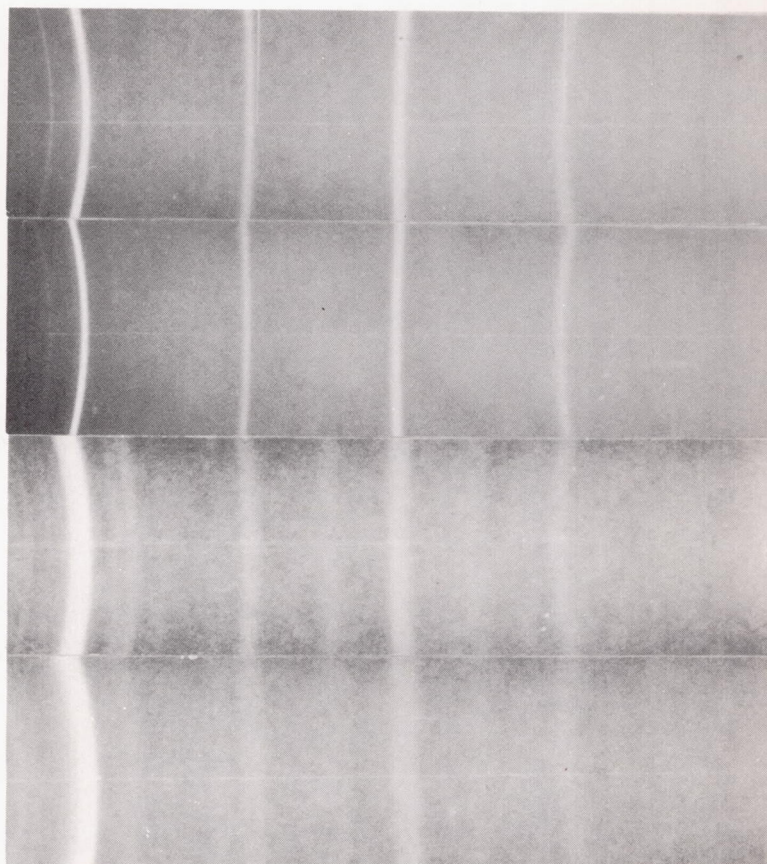
Surface A,  
unworn

Surface B,  
worn  
unscuffed

Surface C,  
scuff  
recovered

Surface D,  
permanently  
scuffed

Figure 5. - X-ray diffraction patterns from SAE 4140 steel slider specimen showing change in crystallite size from surfaces A to D.

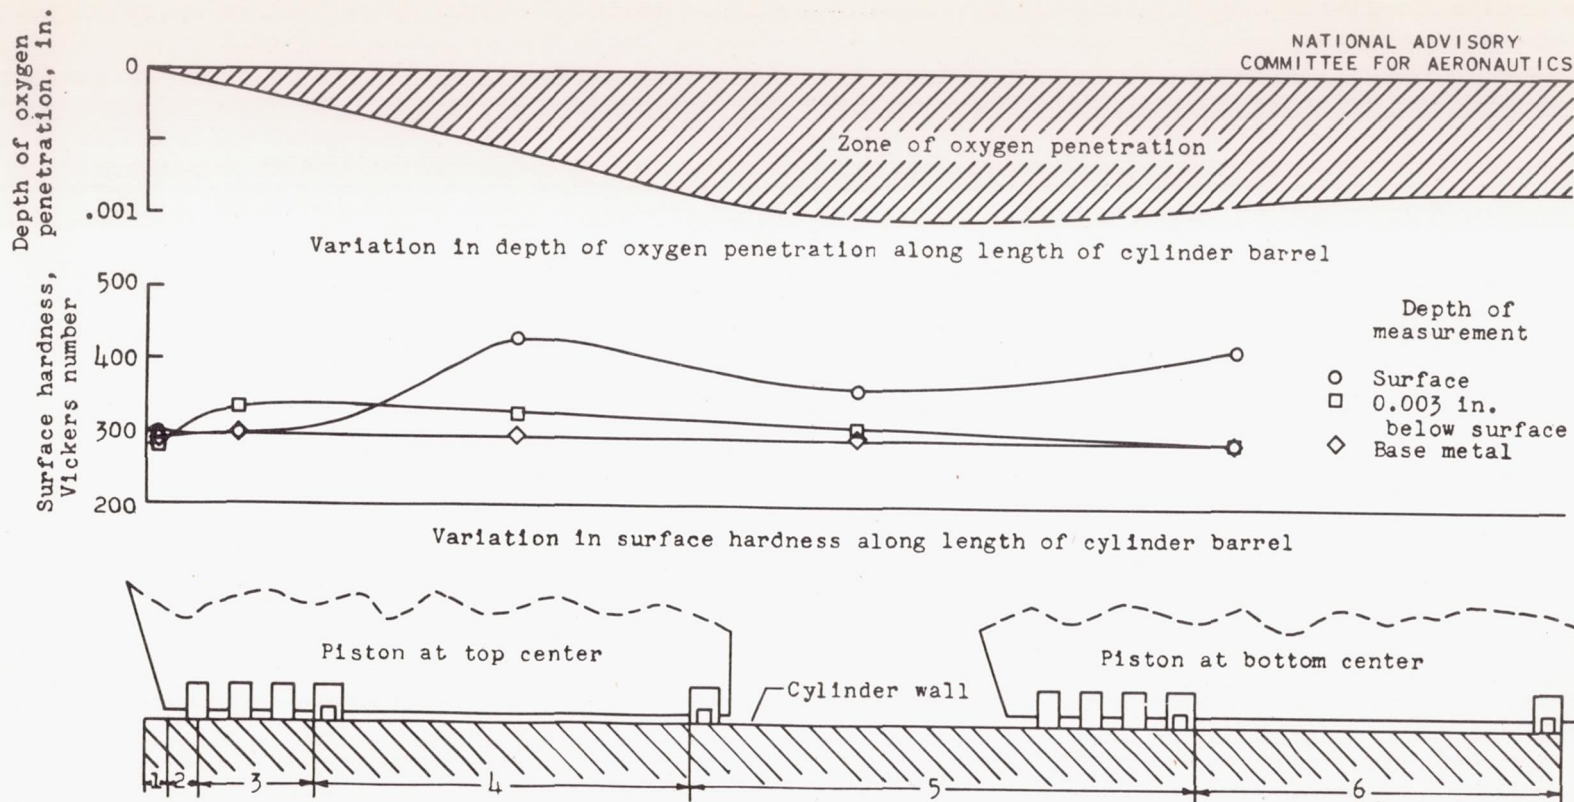
This oxidation is shown in more detail in figure 6 and is labeled depth of oxygen penetration. Oxides existed beneath the surface of the metal everywhere the cylinder had been rubbed. The top 1/8 inch of the barrel was subjected to conditions within the combustion chamber but to no rubbing during engine operation because it was above the region of piston contact. In that top area the oxide existed only as a tenacious blue surface film under a carbon deposit. Variation in surface hardness is plotted on the same abscissa as the oxygen data in figure 6. These data were taken at five representative points along the barrel length.

The wear profile of engine cylinders showed a depression, or highest wear, at the top of compression-ring travel. In this region of high wear where less oxygen penetration seemed to have occurred, the surface had been worn away almost as fast as the penetration progressed. Farther down the length of the cylinder barrel the rate of oxygen penetration seemed to exceed the rate of wear. As a result, oxides formed within a relatively pliable matrix of steel and possibly gave rise to a desirable surface, combining pliability with decreased abrasion, which was continually renewed under the slow abrasion of operating wear.

| Area number | Location of area on cylinder wall with reference to piston | Piston position | Surface condition |
|---|---|---|---|
| 1 | Above piston travel | --- | Thin oxide film, no wear |
| 2 | Opposite top land | Top center | Light pitting |
| 3 | Opposite compression rings | Top center | Heavier pitting and wear |
| 4 | Opposite skirt (high sliding speeds) | Top center | Light pitting |
| 5 | Opposite compression rings | Bottom center | Low wear |
| 6 | Opposite skirt | Bottom center | Very low wear |

Figure 6. - Relations among surface condition, material hardness, and depth of oxygen penetration found on worn - unscoffed SAE 4140 steel aircraft-engine cylinder barrel.

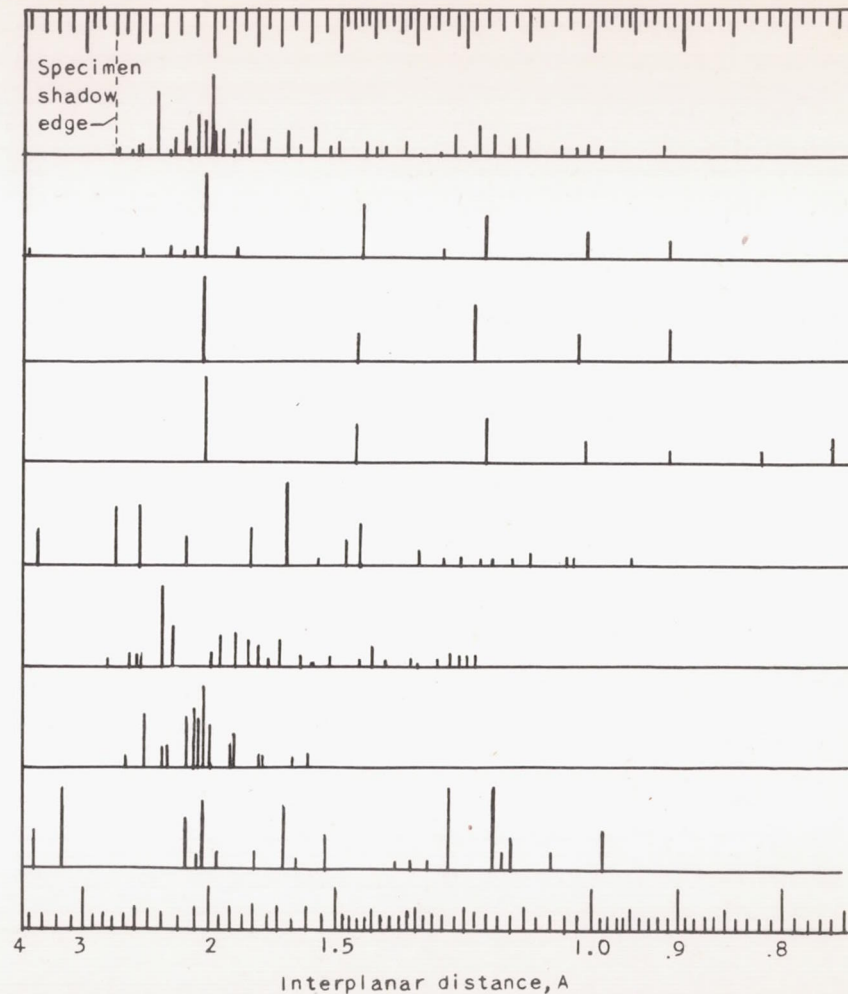
The chrome pattern predominates in all the surface X-ray diffraction patterns. Diffraction examination showed no presence of any chromic oxide,  $\text{Cr}_2\text{O}_3$ , on the unscuffed surface although this surface was expected to contain at least a small amount of this oxide, possibly in the amorphous condition. The compounds  $\text{Cr}_2\text{O}_3$  and chromium carbide,  $\text{Cr}_3\text{C}_2$ , were easily identified on the burnished and scuffed surfaces. An X-ray diffraction pattern containing evidence for these compounds on the scuffed surface is shown in figure 7. A number of diffraction lines that stand alone and belong to none of the previously mentioned compounds may be parts of the diffraction patterns of  $\text{Fe}_2\text{O}_3$ ,  $\text{Fe}_3\text{O}_4$ , the chromium nitrides,  $\text{Cr}_2\text{N}$  and  $\text{CrN}$ , the chromium carbides,  $\text{Cr}_{23}\text{C}_6$ ,  $\text{Cr}_7\text{C}_3$ , and also  $\text{Fe}_3\text{C}$  (on the scuffed surfaces). No completely reliable quantitative trends could be found because of some difficulty in rating diffraction intensities, but the intensities of  $\text{Cr}_2\text{O}_3$  and  $\text{Cr}_3\text{C}_2$  appear to be greater on the scuffed than on the burnished portion. Under the microscope, patches of loose-appearing material with the color and texture of red and black iron oxides and giving dissolution reactions for iron were observed in the surface depressions, apparently as left after pickup from the mating steel slider.

Two cast-iron slider specimens were examined that had been subjected respectively to a normal and to a prolonged run-in procedure. The prolonged run-in increased load-carrying capacity. Figure 7 lists an X-ray diffraction pattern from an unrun surface showing the presence of  $\alpha$ -Fe and one weak ring (interplanar spacing, 4.5 Å) that coincides with the strongest line of the graphite pattern. A number of weak lines and one strong line coincide with all the strong lines of  $\text{Fe}_3\text{C}$ , and several unidentified lines also show. On all the surfaces,  $\alpha$ -Fe was observed. The presence of graphite was more completely indicated on the worn and scuffed surfaces. Hardness values showed decrease as scuff condition was approached (fig. 9) and crystallite sizes increased.

Figure 7. - Typical electron and X-ray diffraction patterns from specimens of chrome-plated cast-iron and cast-iron riders and standard X-ray diffraction patterns of materials identified.

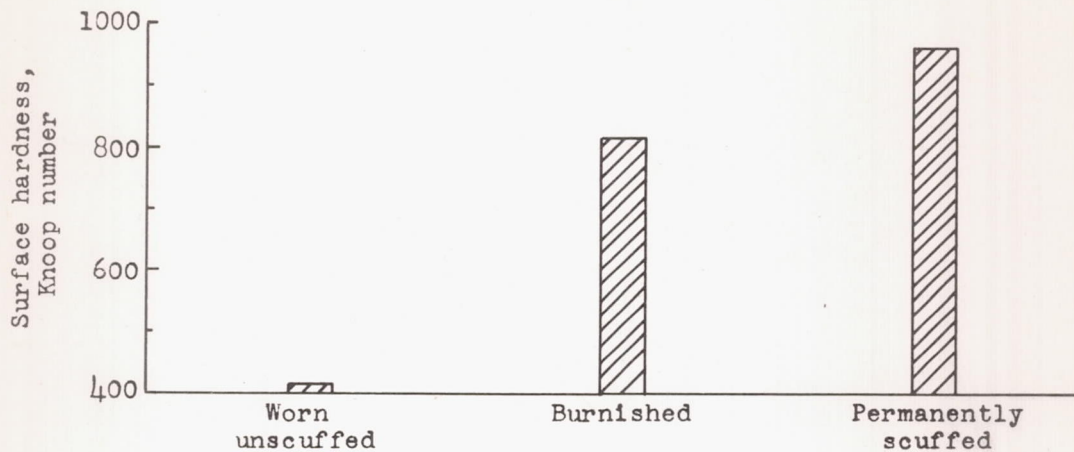
The variations in hardness among the different surface conditions are graphically illustrated in figure 8. Crystallite-size determination showed no large differences. A decrease in crystallite size was expected approaching scuff and such a trend was indicated, but the differences were within experimental error. The sizes were of the order of  $14 \times 10^{-7}$  centimeters.

The hardness of the chrome surface increased markedly for the burnished surface condition and corresponded with the formation of  $\text{Cr}_2\text{O}_3$  and  $\text{Cr}_3\text{C}_2$ . The cast iron softened throughout the runs and the crystallite size increased. The end result at scuff was approximately the same for normal and for prolonged run-in. The prolonged-run-in surface, having the higher load at failure, showed slightly less softening than the normal-run-in surface. The more pronounced crystallite-size increase for the worn-unscuffed surface under prolonged run-in seems incompatible with increased resistance to failure. Chemical changes may account for the reversed trend for this material with respect to the over-all trend associated with the other materials, although such changes were undetectable in this case. Relatively, an opposite trend is indicated for any one of these materials when the change in hardness is compared with change in crystallite size between unscuffed and scuffed surface conditions.

Figure 8. - Relation between hardness and surface condition of chrome-plated cast-iron rider specimen.

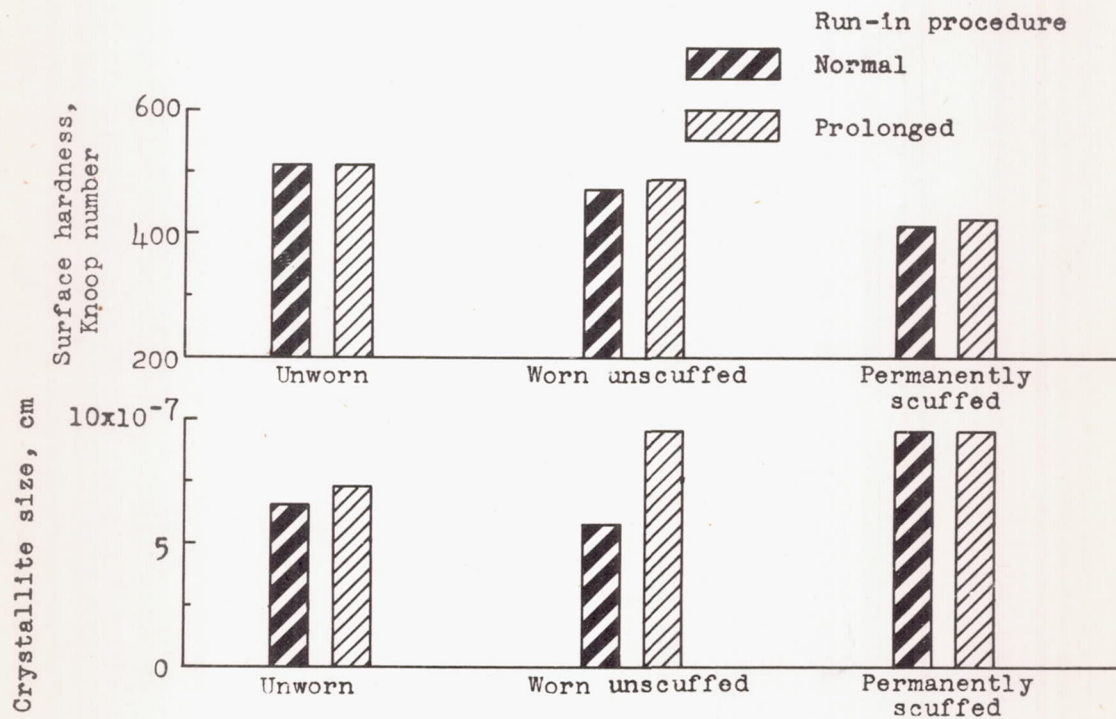
Figure 9. - Relation between surface changes and surface condition of cast-iron slider specimens.
